2017/SOM1/EPWG/030

Reviews and Reflections on 2016 Typhoon Season in Chinese Taipei

**11th Emergency Preparedness Working Group
Meeting
Nha Trang, Viet Nam
18-19 February 2017**

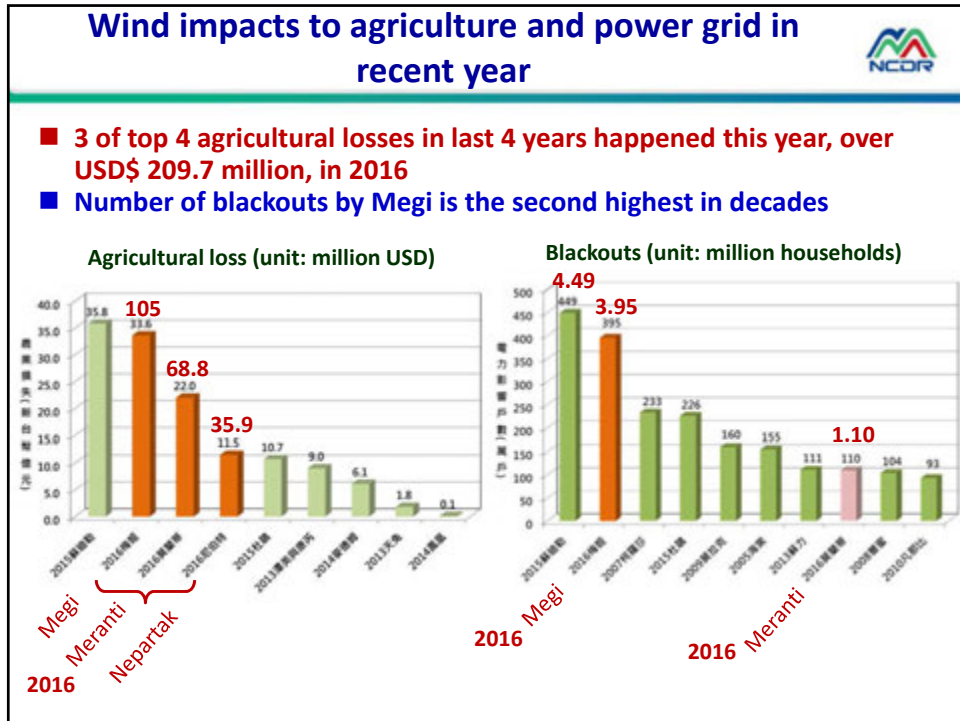
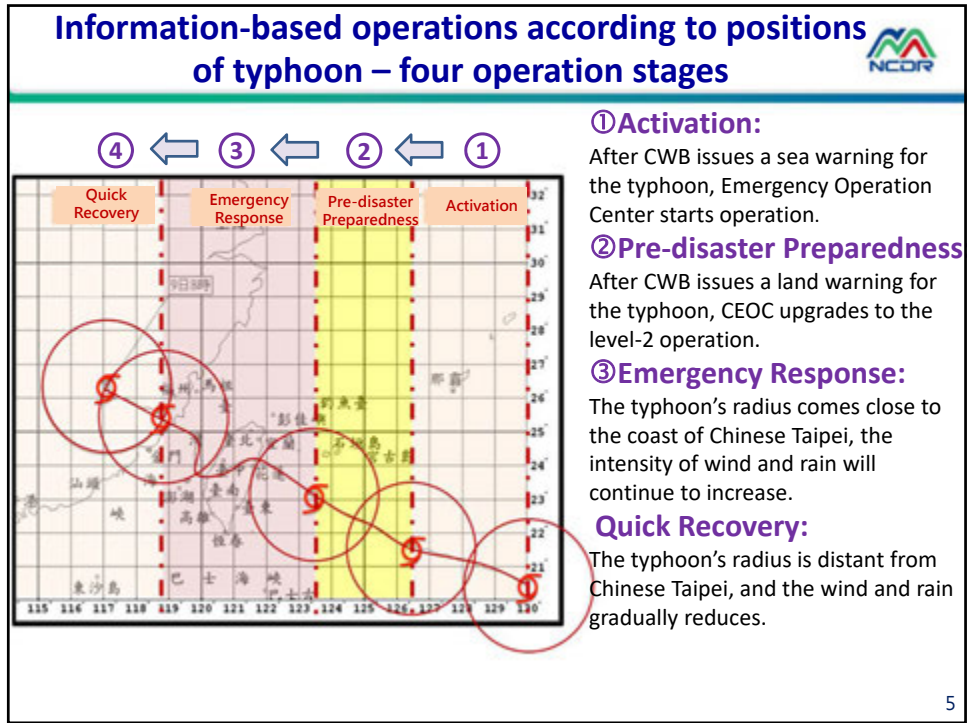
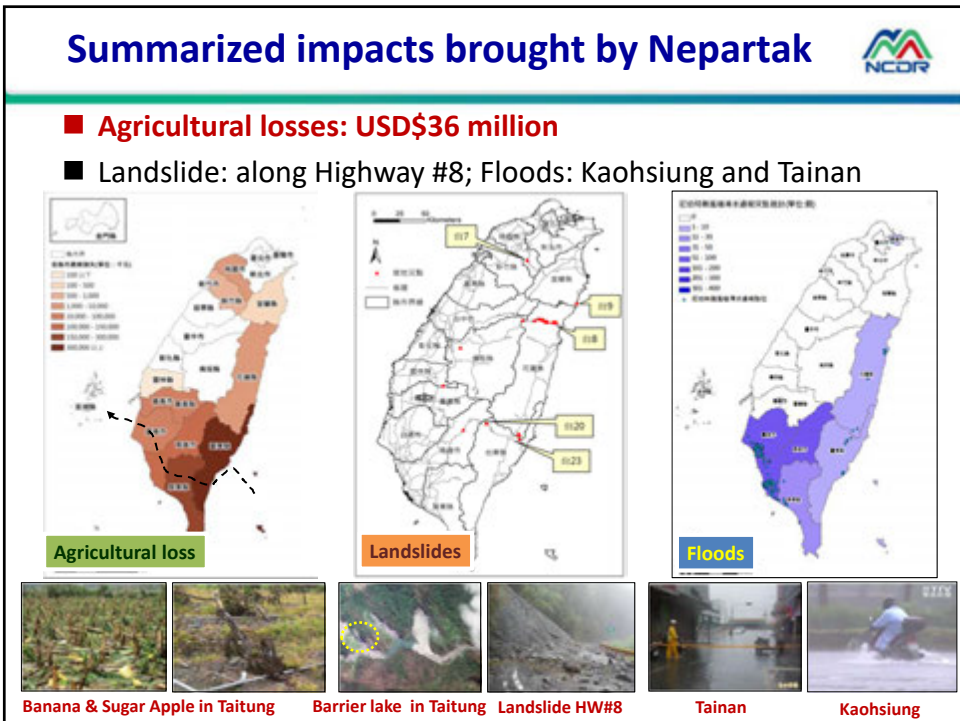
- **The first typhoon of 2016, Nepartak, formed in July**
 - a late-first one compared with historical records
 - but reached Category 5, equivalent to a super typhoon
- **Wind damages to lifeline systems are major impacts**
 - power, telecommunications and transportation systems
- **Typhoon Meranti and Typhoon Megi**
 - million-household blackouts
 - Typhoon Megi caused up to 3.22 million households at blackout for days.

Wind damages in Taitung

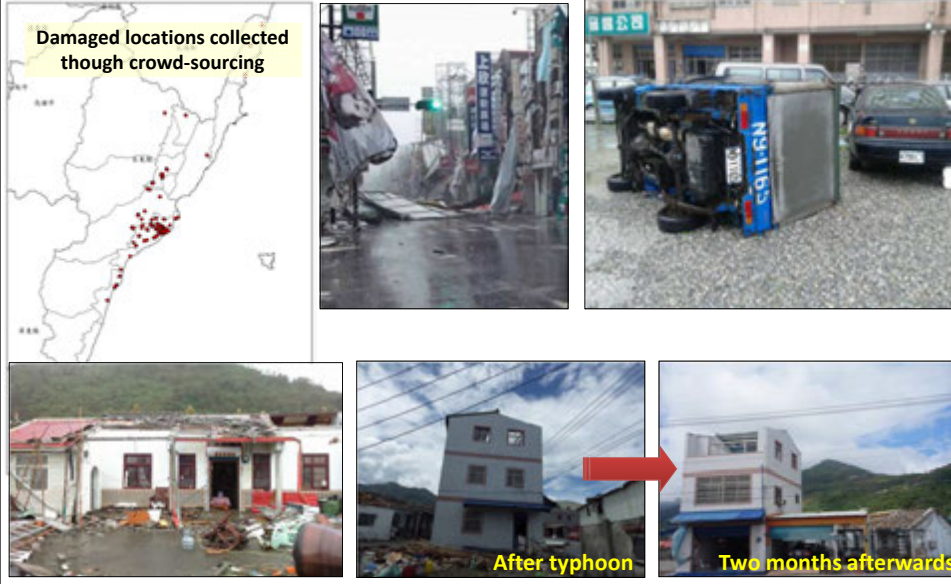
Super Typhoon Meranti

- Meranti decreased to moderate on during approaching China.
- Lanyu and Kinmen measured strong wind of Beaufort scale 17.

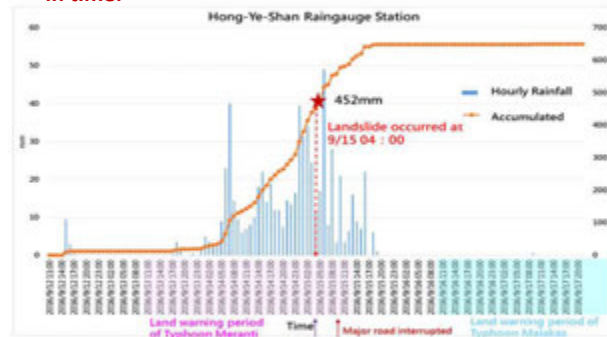
New landslide area (including deposition area) is around 19.6 ha.

Thailand THEOS image

NDVI image

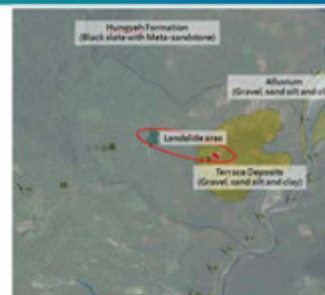
Geological environment of Hong-ye Tribe (Taitung)

- **Hungyeh Formation**, the major unit of the landslide area, is mainly composed of **black slate with Meta-sandstone**.
- The slope of the landslide area are mainly between **30-45degree**.
