Proposal for Research and Investment Activities in the Coast and Estuaries (A Case Study in the North Central Coast of Viet Nam)

PROPOSE RESEARCH AND INVESTMENT ACTIVITIES FOR VIETNAM COAST

Case study on change of coast and estuaries in North Central Coast of Vietnam

Viet Nam Academy for Water Resources

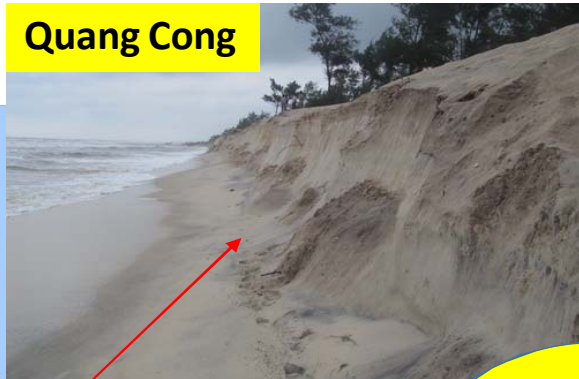
Quang Cong

Eroded continuously each year

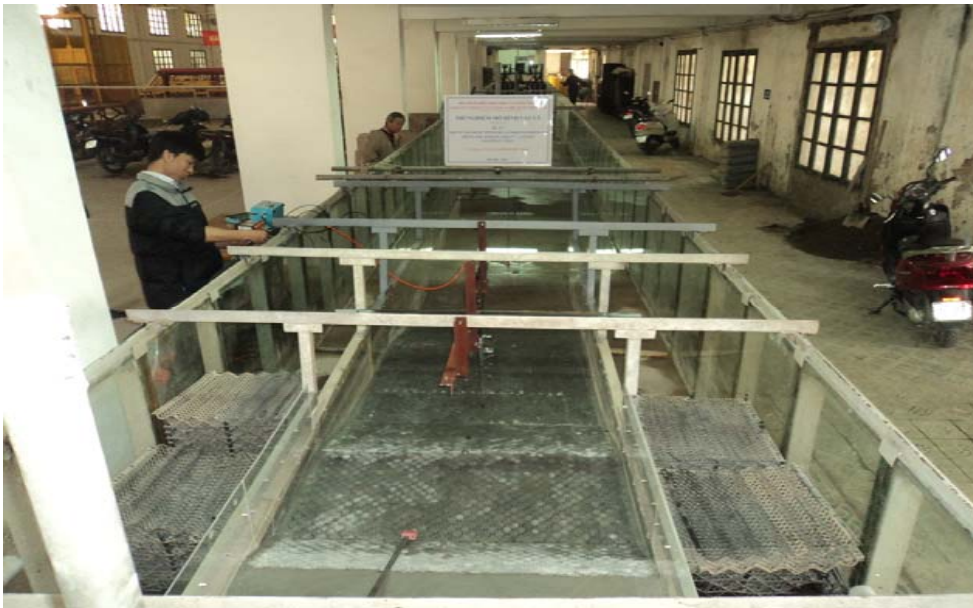
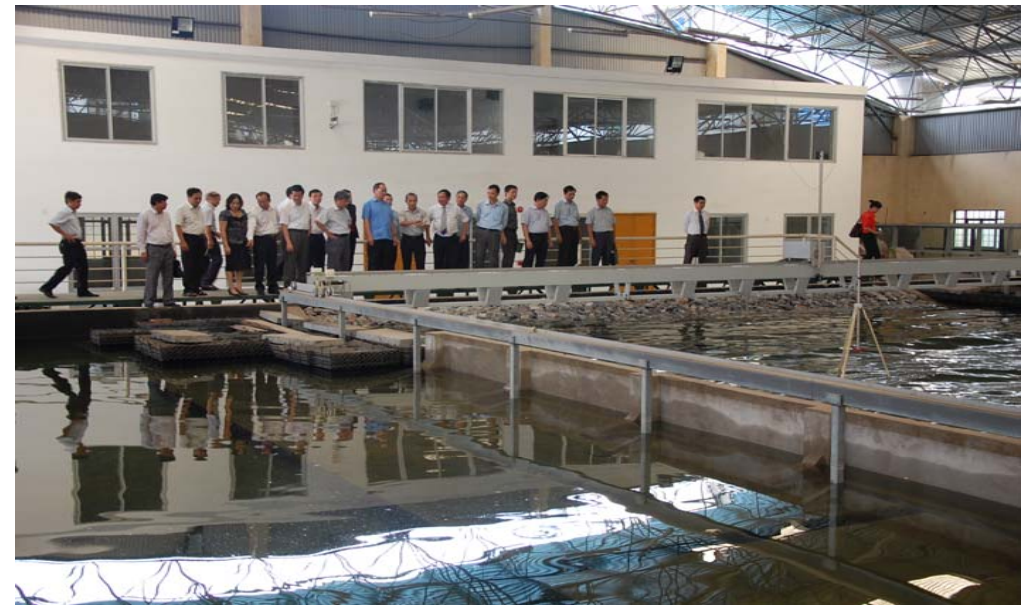
- ❖ Researching on wave flume, wave and tide basin for measures

Wave flume, wave and tide basin in Viet Nam Academy for Water Resources

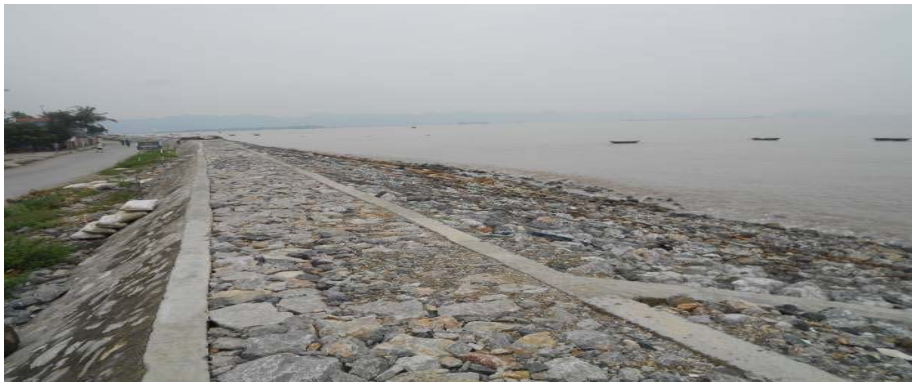
rip-rap revetment with frame

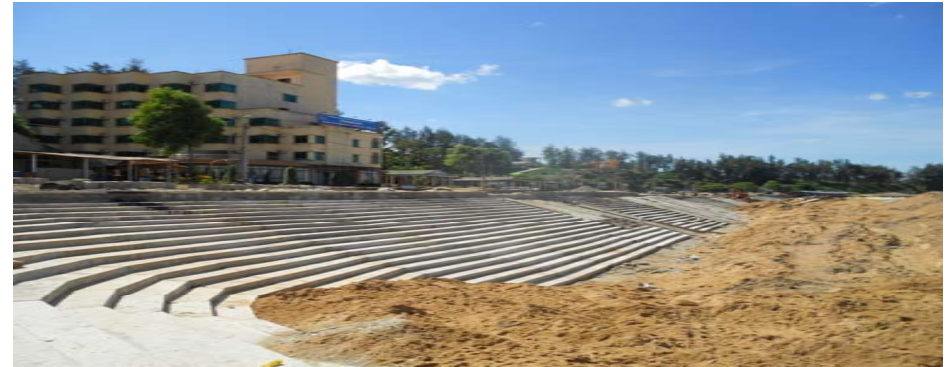
Stepped concrete block revetment

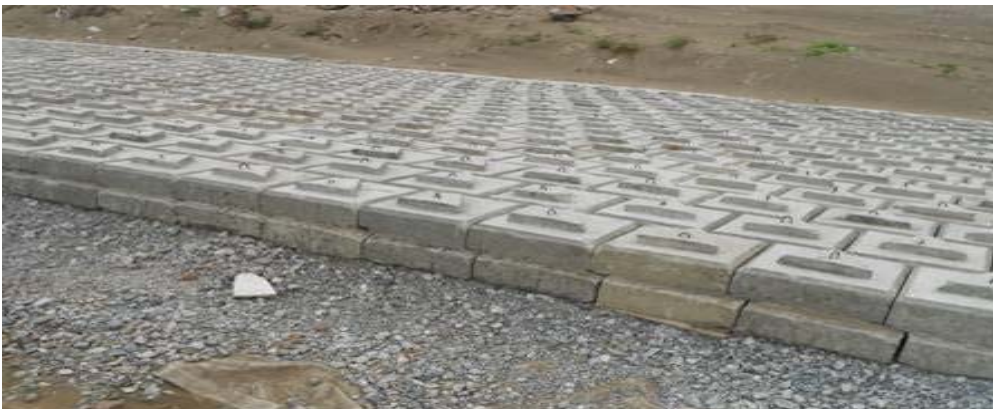
Articulating Concrete Block System

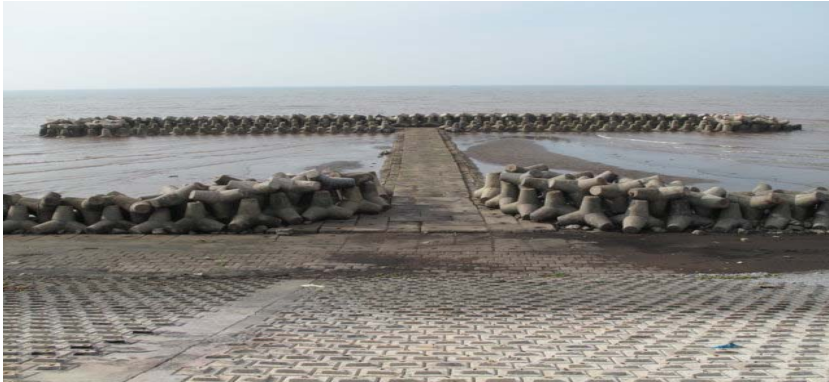
Tetrapod

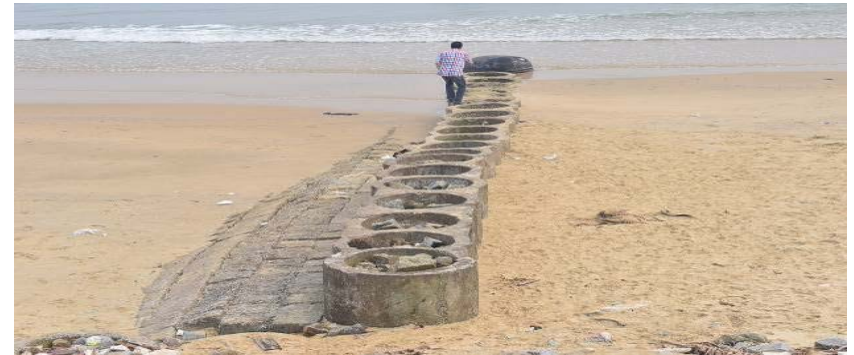
Cement-pipe groyne

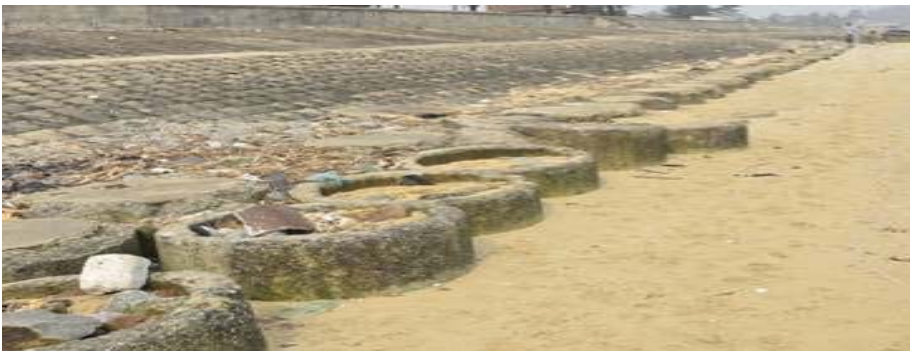
Protect revetment's toe by Cement-pipe

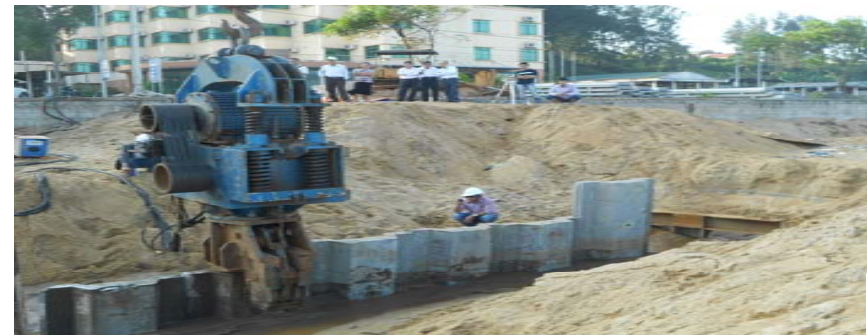
Prestressed concrete piles

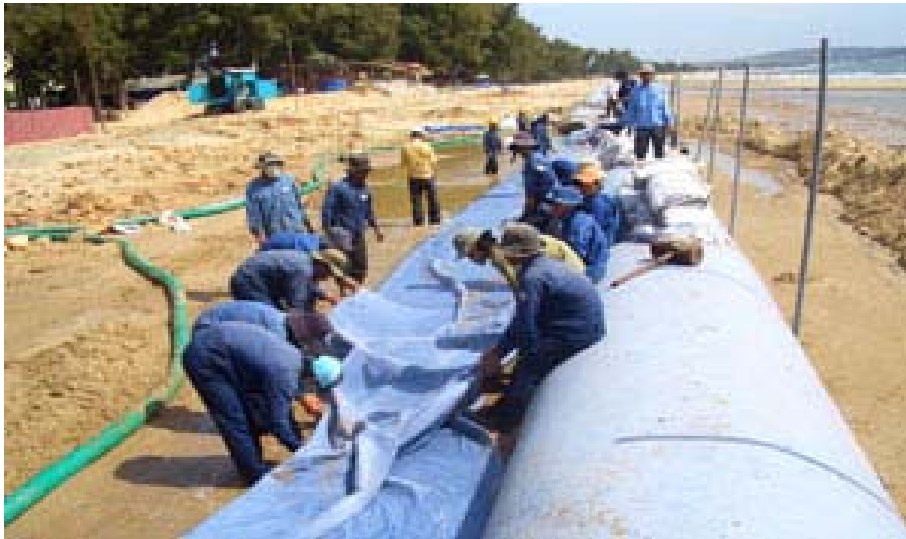
Stabiplage

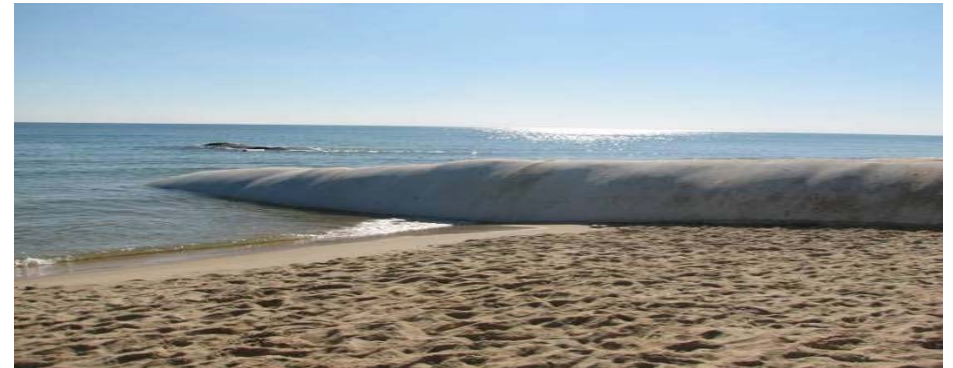
Groyne with stabiplage techniques

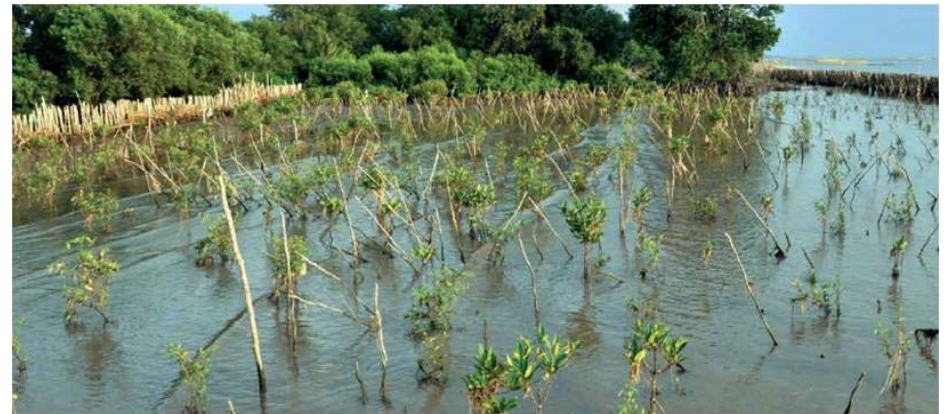
Mangrove planting

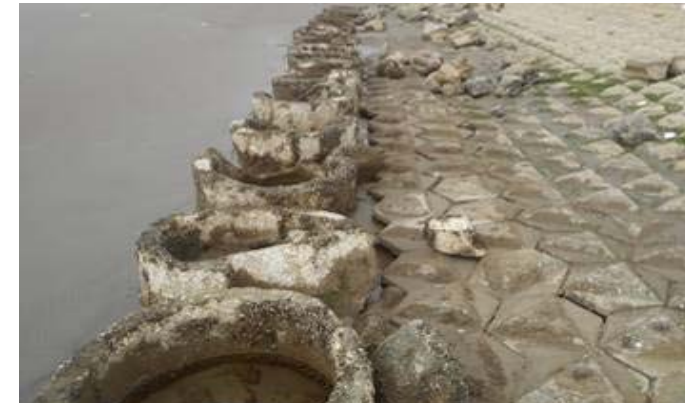
Cement pipes at toe of revetment were broken by erosion

- Groins: There still has mistakes in designing of space allocation of groins system, detached breakwater...
- Revetment: Design parameters of revetment has not been suitable for both patterns: berm, slide roof, toe...

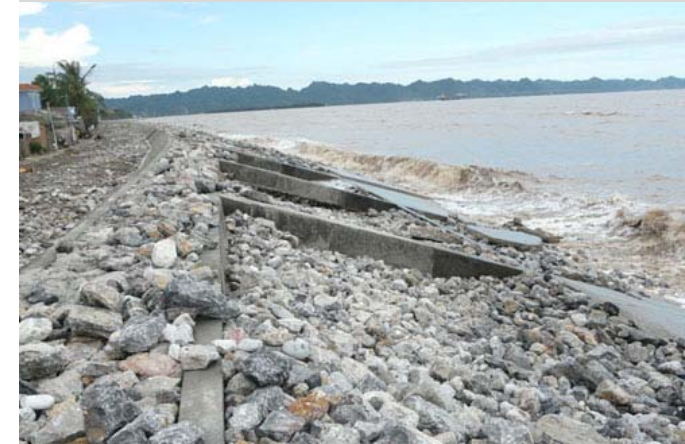
rip-rap revetment with frame was broken by wave

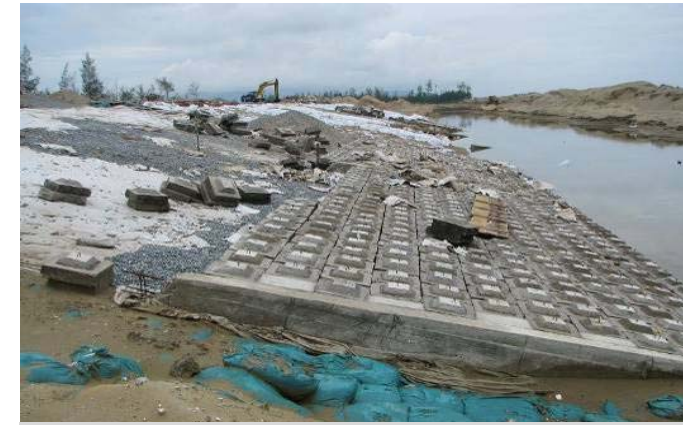
*construction of revetment
on unstable ground*

- Roof reinforcement: Concrete blocks are produced in the construction site so it is difficult to control the quality;
- Toe reinforcement: space between components of revetment's toe is not suitable.

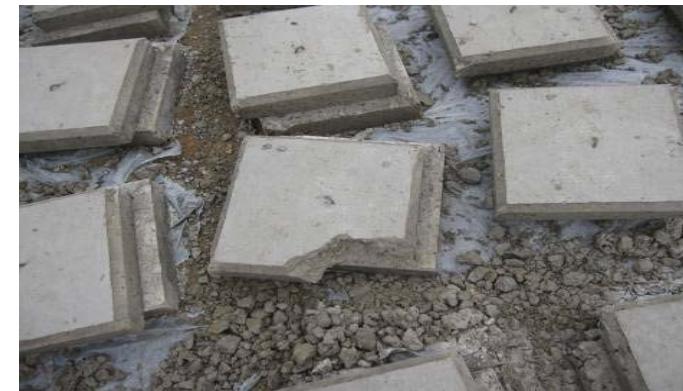
*Concrete blocks are produced
with low quality*

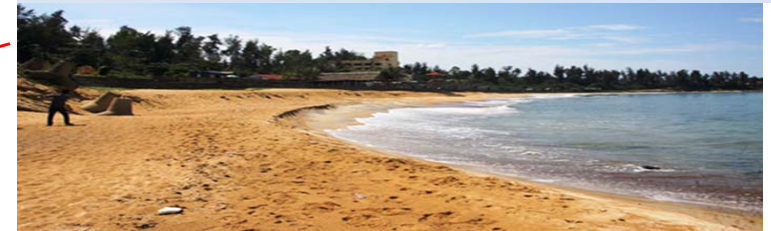
Eroded beach at the North of river mouth

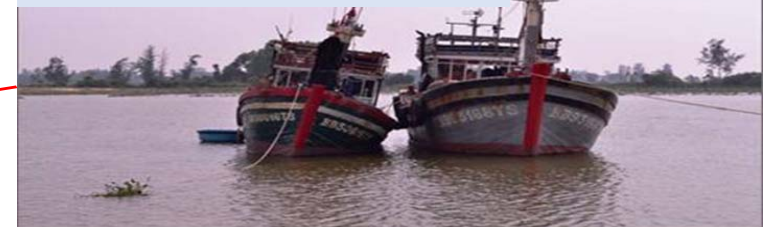
Deposition in river mouth

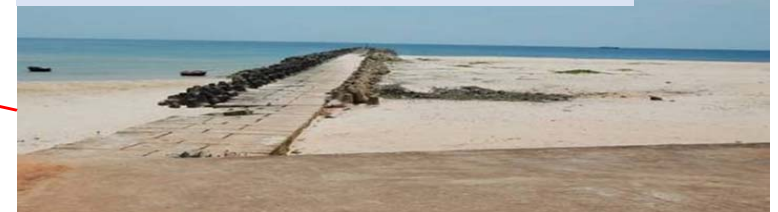
Jetty at the South of river mouth

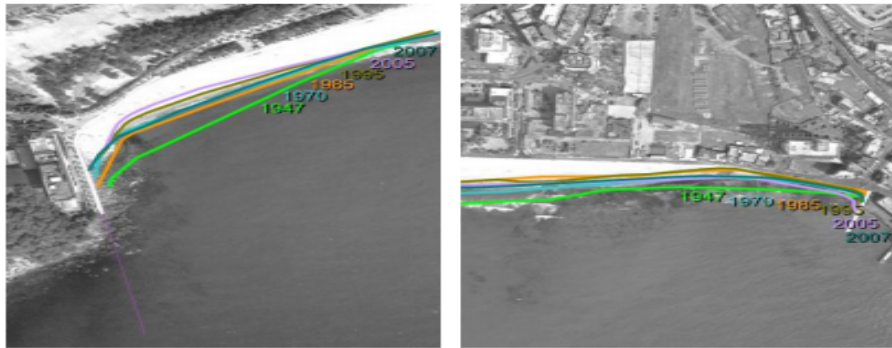
Figure 2. Historical records of shoreline change in Haeundae Beach. (a) Joseon Hotel area (west side). (b) Mipo area (east side).

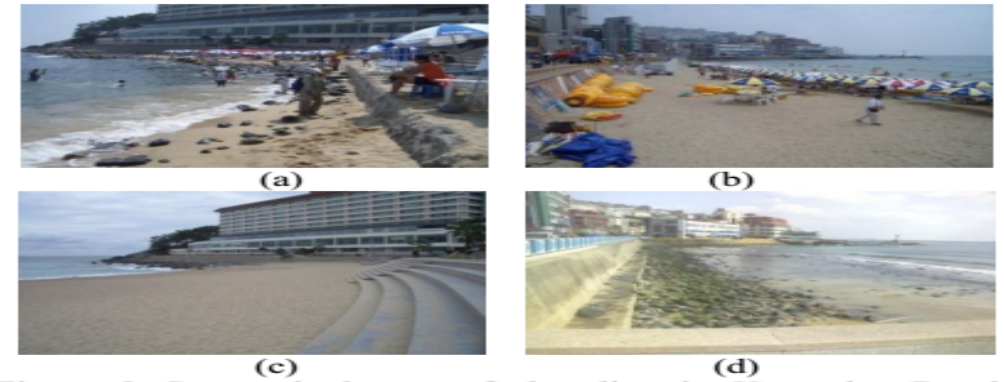
Figure 3. Seasonal change of shoreline in Haeundae Beach. Joseon Hotel area (west side) in summer (a) and winter (c); Mipo area (east side) in summer (b) and winter (d).

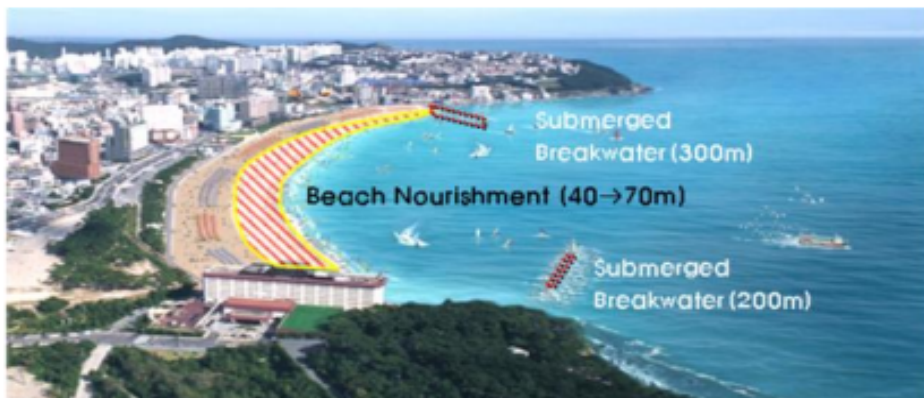
Figure 9. Beach erosion countermeasure plan for Haeundae Beach.
